OVERVIEW

With one season of field service experience three service items have been noteworthy and should be completed during the next unit service.

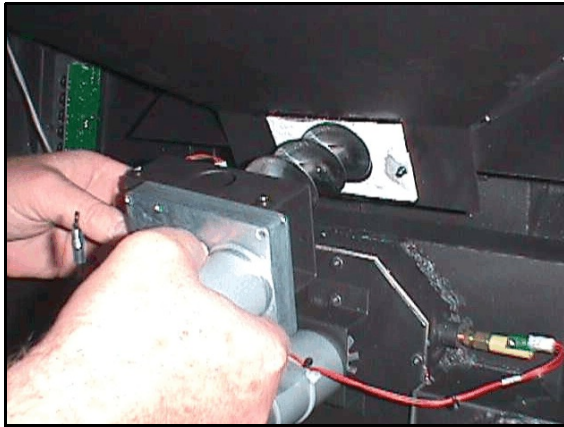
Figure 1

Feed System Gasket and Attachment Nuts: Feed system attachment in past EF units had been accomplished with wing nuts. We have noted that the nuts tightened by hand may not be sufficient to properly secure the feed drive. If the drive become loose the feed gasket may fail and allow saw dust to fall into the cabinet. To correct this we have available 10-24 washer locking nuts to replace the wing nuts. Replacement of the feed gasket should include gluing the gasket to the bottom of the feed hopper using silicone sealant.

- 1) Remove the units rear panels to gain access to the feed drive. Empty the hopper of fuel. Loosen and remove the wing nuts. Lower the feed drive from the hopper (**Figure 1**). Remove old gasket.
- 2) Apply automotive type silicone gasket material around feed drive hole (**Figure 2**).
- 3) Press silicone applied gasket side to bottom of hopper (**Figure 3**).
- 4) Carefully install feed drive so as to not damage gasket. Install new lock nuts and tighten with 3/8 wrench (**Figure 4**).

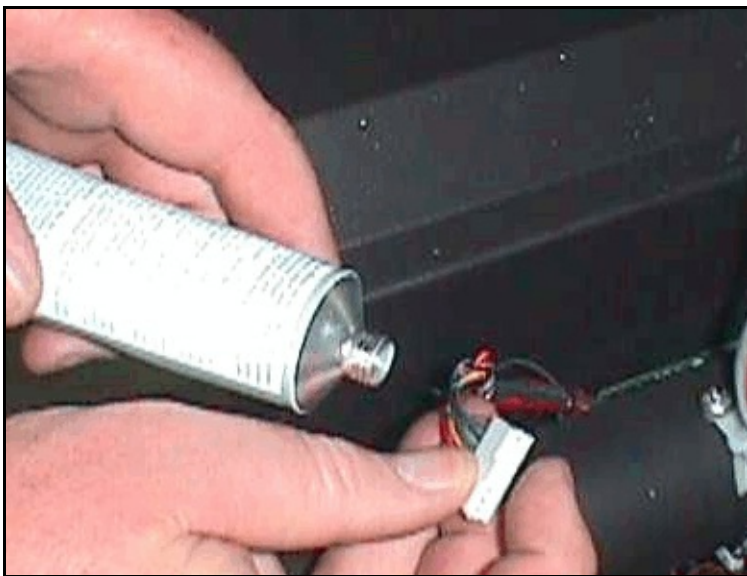
Figure 5

Sensor and Switch Harness Connections: These digital components connect to the main circuit board through the main wiring harness. The connections utilize industry standard pin and sockets.

Operating at low DC voltage these connections are subject to vibration, dust, and moisture. To minimize the loss of contact these three connections should be coated with a small amount of

“Silicone Di-Electric Compound”. This non-hardening silicone will keep moisture and dust from effecting the connection along with minimizing vibration. Available at auto parts and electronic stores a small tube will service many units.

- 1) Carefully pull the harness connection end connector from each of the two sensors and switch board (**Figure 5**).
- 2) Apply a small amount of di-electric lube to the bottom of the connector allowing the lube to push into each pin opening.
- 3) Apply a small amount to pin area on receiver and plug harness back into original connection.

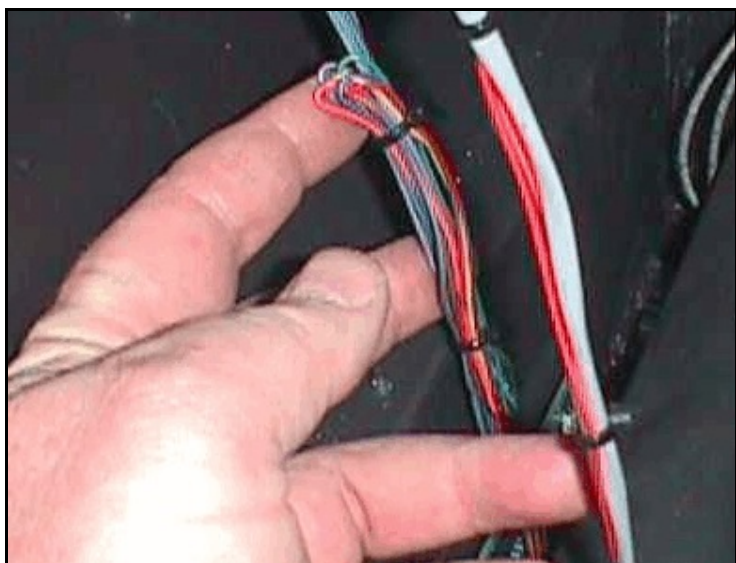
Figure 6

Checking Harness for Proper Slack: During unit assembly the harness is routed through the cabinet and bundled to keep wiring away from hot surfaces. The bundles may cause the harness connections to be pulled during servicing and allow for a poor connection. Check the harness and confirm there is at least ½" play when moving the bundle or harness up (**Figure 6**).

- 1) Check all harness connections to make certain there is adequate slack. If additional slack is needed carefully pull additional wire from bundles.
